Sustainable housing

Forensics of the

Duduza tornado in 2011

On the evening of Sunday 2 October 2011 a tornado caused devastation in a section of Duduza, on the East Rand, resulting in major damage to infrastructure and houses. In an attempt to identify structural and building defects to be avoided in the provision of future housing, Fred Crofts in this article reports on the damage observed as a result of nature's wide-scale 'destructive testing'.

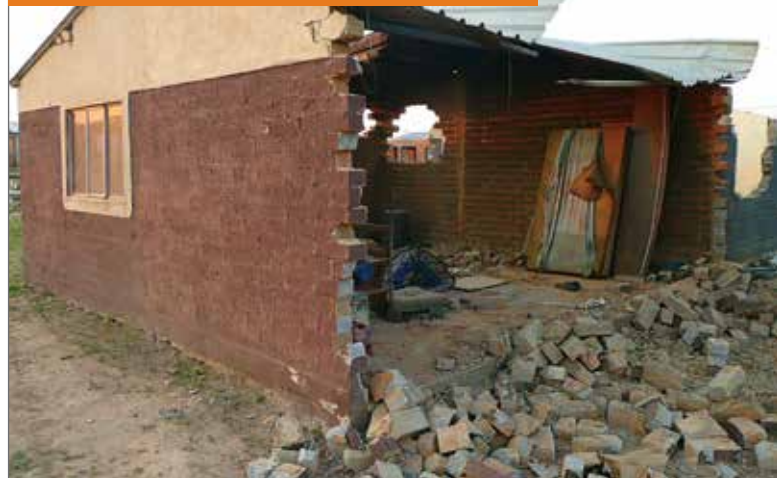
Photograph 1 shows a collapsed wall panel (the entire façade of the dwelling) due to compromised support conditions, with the tooothing-in of return walls. The dimensional change of high shrinkage concrete masonry units, having not been manufactured in accordance with the minimum requirements in SANS 1215-1984 (the standard specification for the manufacture of concrete masonry units), will further weaken the masonry bond at supporting return walls if walls are not built up simultaneously.

Photograph 1: Collapsed wall panel due to tooothing-in of masonry units at return walls

- Masonry walls should be built up and raked back gradually as opposed to building wall panels and tooothing-in at return walls.

- ▶ Wall panels supported by return walls using masonry units of the same geometry in both walls should not be toothed-in, but should be built up simultaneously, and bonded.
- ▶ Wall panels supported by abutting return walls using masonry units of dissimilar geometry that cannot be bonded, i.e. when maxi masonry units are bedded on the 140 face and the 90 face for external and internal walls respectively, should be mechanically anchored using metal ties or dowels.

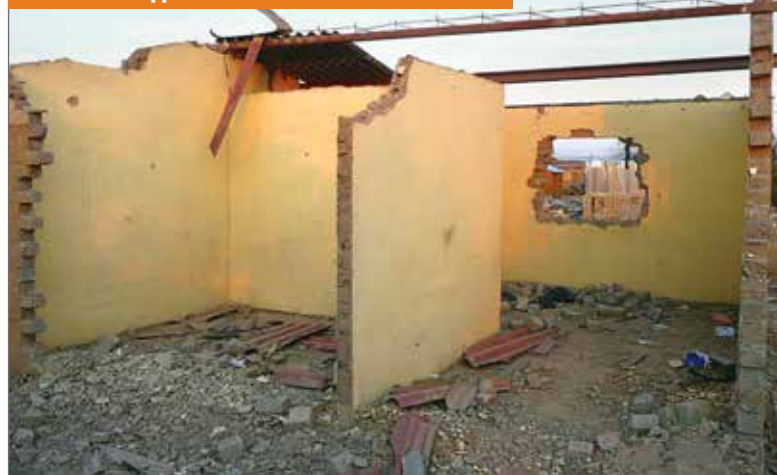
Photograph 2 shows the outward collapse of a masonry wall panel. No provision was made to support the external wall panel to the abutting central supporting wall, by tying the two walls for instance to resist the negative wind pressures (suction) on the leeward side of the dwelling.

Photograph 2: Collapsed wall panel due to un-bonded central wall support

of the roof, with the wind lifting the roof together with the bricks. In some instances purlins were not anchored on central supporting walls, as can be seen in Photograph 2.

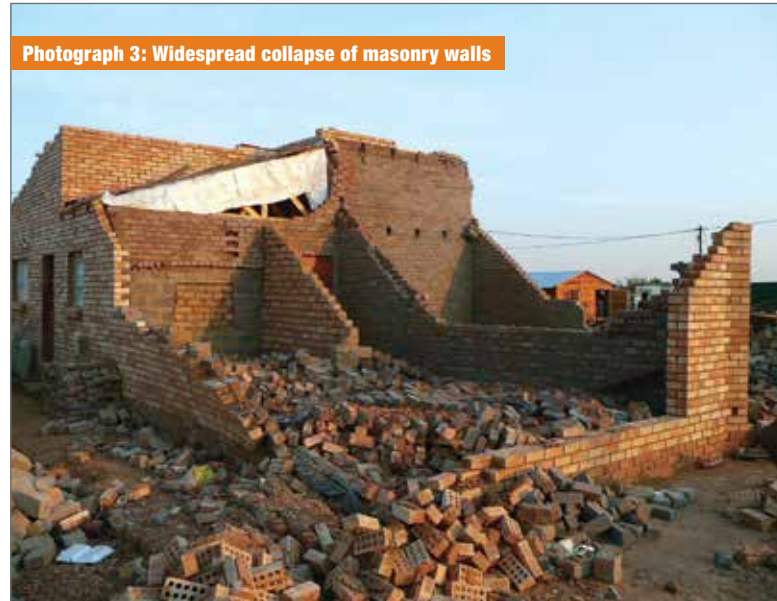
The lack of composite action in a double leaf masonry wall reduces not only its load-bearing capacity, but also its flexural resistance against lateral wind forces, as shown in Photograph 3 where the total collapse of the dwelling occurred. The omission of wall ties in double leaf walls (collar-jointed walls) is in contravention of the NBR; this requirement is a recent addition (2005) in SANS 10400-K: Walls.

Photograph 3 shows the progressive lean of the end wall akin to paging a leaf in a book.

Photograph 3 shows the use of fired clay masonry units in the external leaf and concrete masonry units in the internal leaf of the double leaf wall. The use of dissimilar masonry materials is only justified if separated completely by control joints or horizontal damp proof courses or movement joints. Differential movement (moisture or thermally induced) will compromise the serviceability of a wall where the dissimilar materials come in contact with one another and may result in the structural integrity of the wall being compromised, due to increased stresses in critical planes in the wall reducing its load-bearing capacity and/or flexural strength.

Photograph 3: Widespread collapse of masonry walls

- ▶ Double leaf masonry walls should be cross-bonded (with masonry units or mechanically) and the collar joint between the two leaves should be solidly filled with masonry mortar.
- ▶ The cross wires of longitudinal masonry reinforcement (brick-force) is not a substitute for metal ties.

- ▶ Do not use dissimilar masonry units in the same wall. As a matter of fact, have a single type masonry unit delivered to site, especially if supervision is lacking.

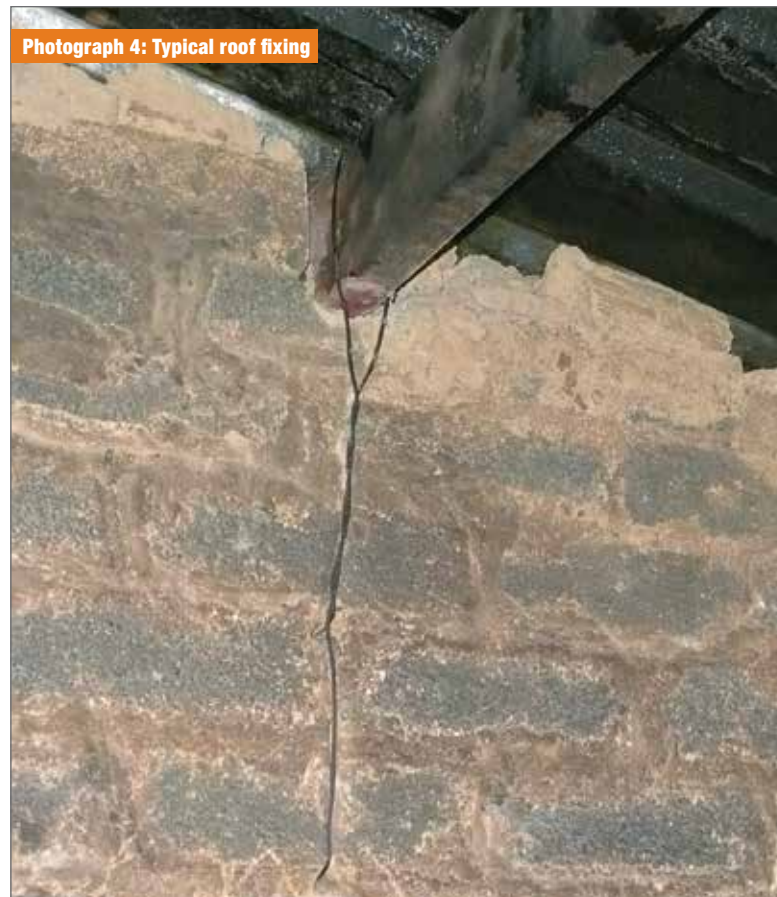
Photograph 4 shows the typical roof fixing used for most RDP houses at Duduza, i.e. long span purlins are spaced at larger centres and have not been adequately anchored into walls. The roof wires were too thin, and were affixed with a slack and not anchored with the correct number of masonry courses. Widespread roof failures occurred due to inadequate anchoring

Photograph 4: Typical roof fixing

- ▶ Roof fixing should consist of adequate anchors that are securely anchored down with a sufficient number of masonry courses.
